# Pad Printing

## Troubleshooting Guide

Rev 01/01/20

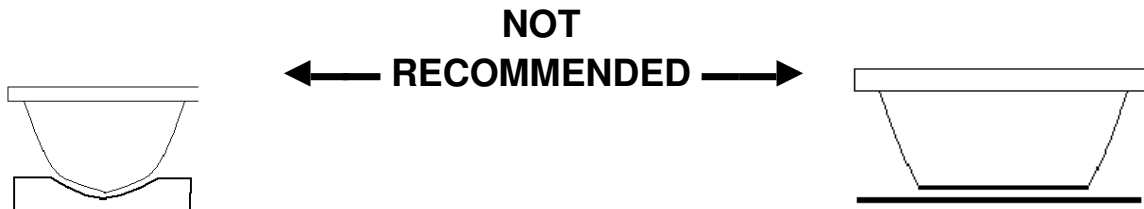
When there is very little or no angle of descent, a blotting effect takes place which results in very poor print quality (see illustration below.)

**CAUSE: Angle of descent incorrect.**
